Bravo

Troubleshooting Guide

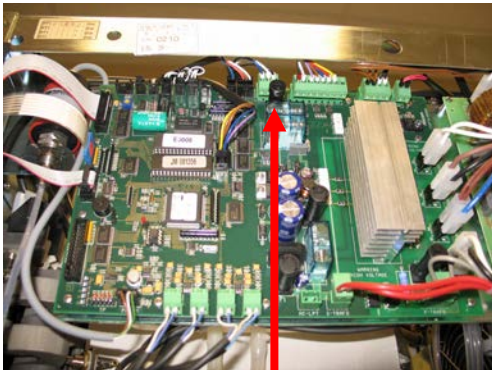
GAM PCB

Go to the Service menu (service code ++ -- ++ --), device test, manual, locking device. Select the locking device then activate the door motor and check if the door hook is closing and opening. If the door motor does not operate check fuse F4 on the Bravo Gam PCB and check the red reset button on the Troll PCB. Check the Pressure Switch you should have continuity between the two white wires.

Fuse F4

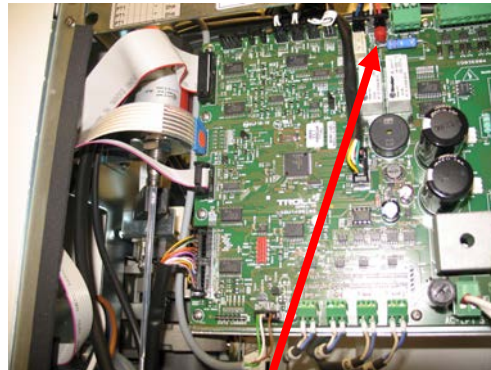
Troll PCB

Red Reset Button

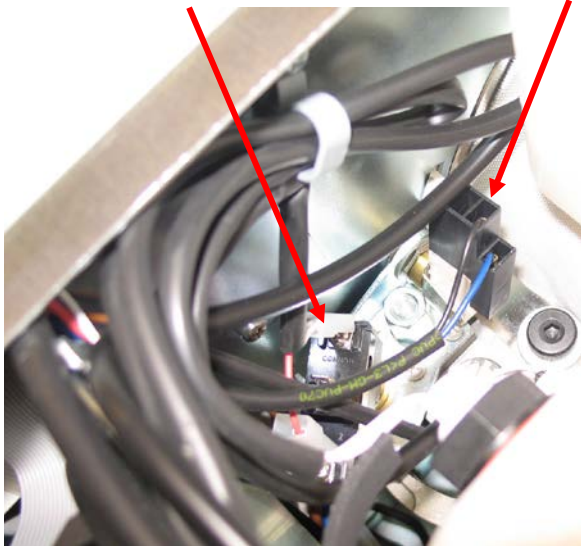
**Hook Micro switch
#43300080000**

Door Approach Micro switch is a normally open switch.
Hook Micro switches are normally closed switches.

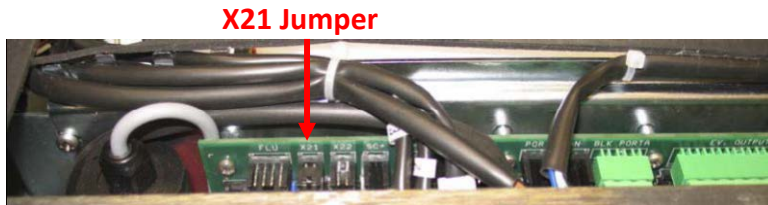
Bravo Door Motor Reset for Gam PCB

Remove the cover, and then remove jumper X21 located above the battery.

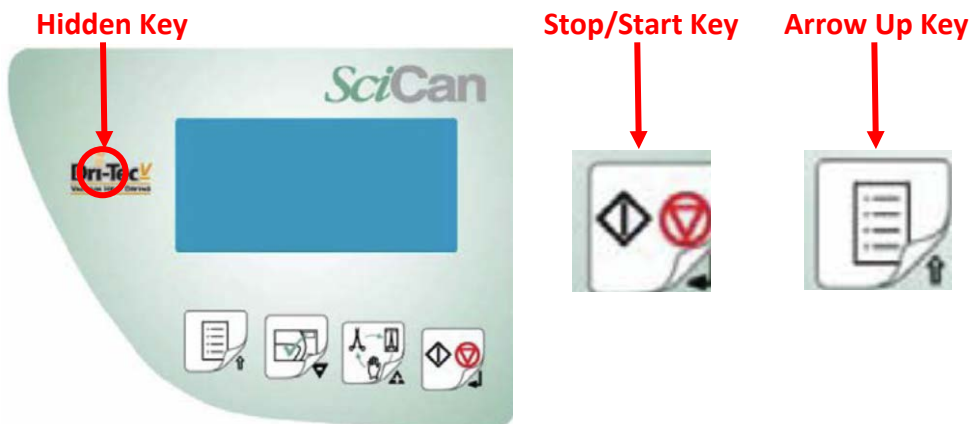
Push and hold the hidden key while turning the power ON. The message "Locking Device will appear on the LCD. Release the hidden key and press the stop/start key to reset the door locking mechanism. Open the door and press the arrow up key to exit. Turn the Bravo OFF and reinstall X21.

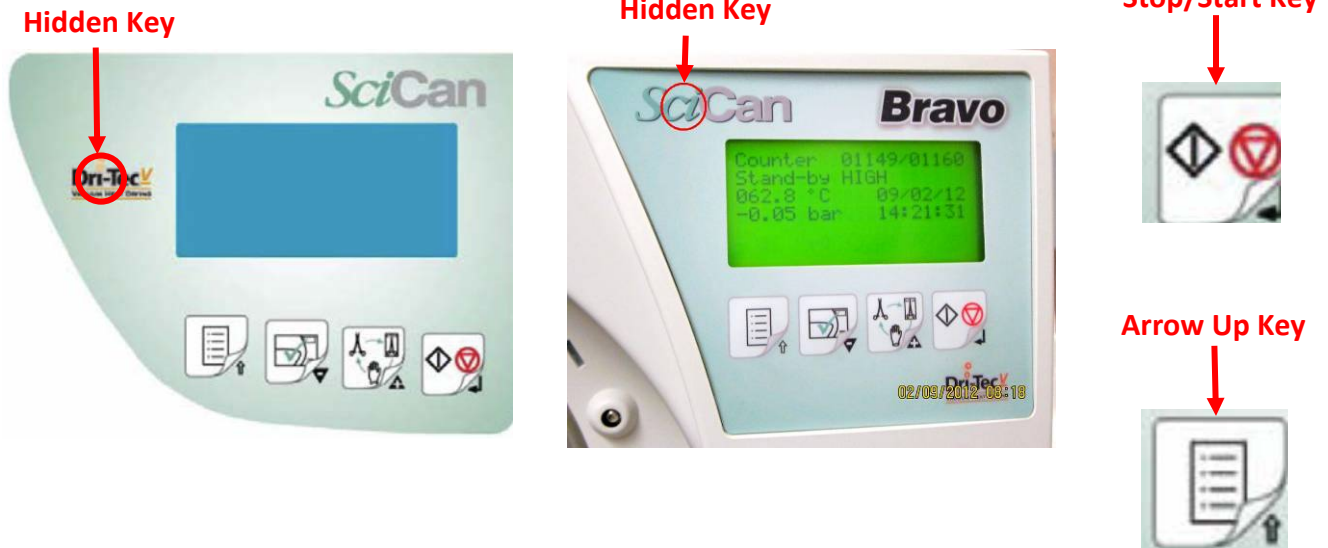
Bravo Door Motor Reset for Troll PCB

The cover does not need to be removed. Push and hold the hidden key while turning the power ON. The message “Locking Device will appear on the LCD. Release the hidden key and press the stop/start key to reset the door locking mechanism. Open the door and press the arrow up key to exit. If the door overload function has been triggered, there is no more beeping sound when pressing the keypad remove the cover and reset the red button on the PCB.

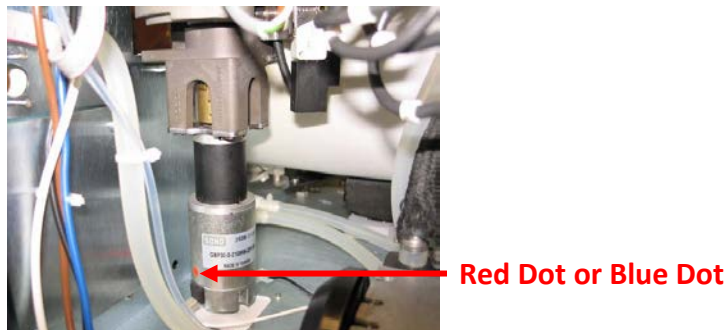
The Bravo Door Motor is a DC motor. The voltage to the motor should read 24 -29 VDC. If replacing the door motor the white wire must be connected to the terminal with the red or blue dot to the left of the label.

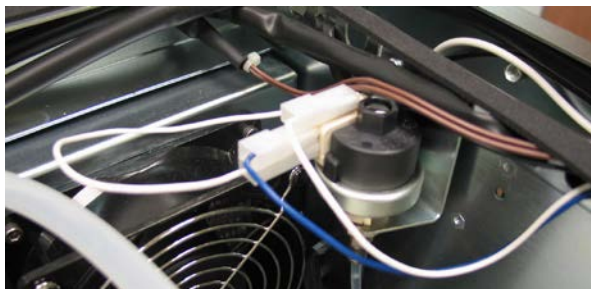
If there is no voltage to the door motor bypass the pressure switch. Remove the two white wires and connect them together. If you now have voltage to the door motor the pressure switch is defective.

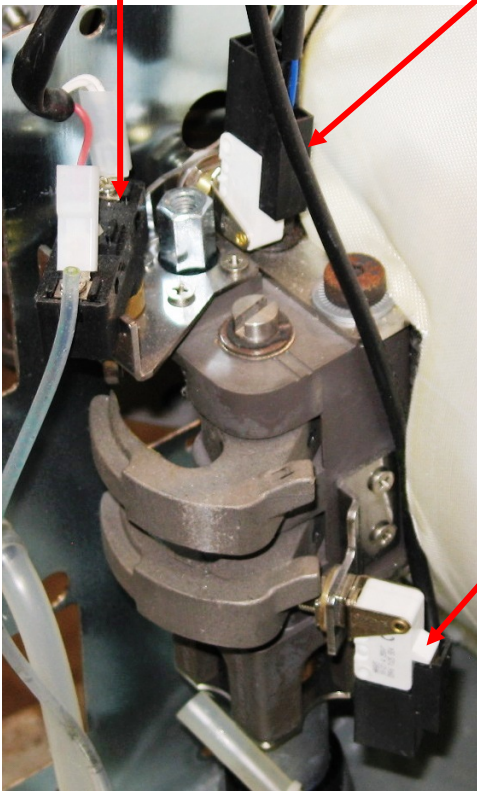
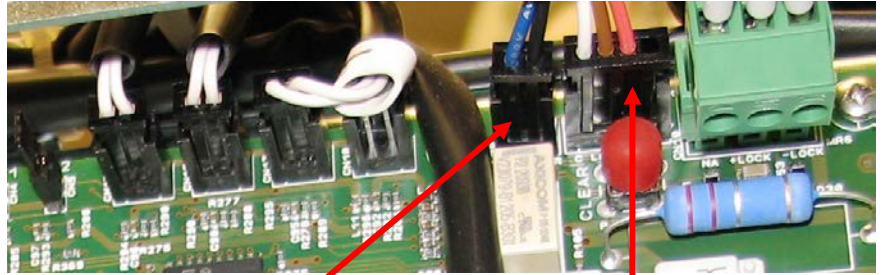
Door Closed
Hook Micro switch

Door Open Micro switch

Blue & Black wires to Door
Closed Micro switch

Door Open
Hook Micro switch

White wire common to open & closed Door Hook
Micro switches.
Brown wire goes to door open Hook Micro switch
Red wire goes to door closed Hook Micro switch

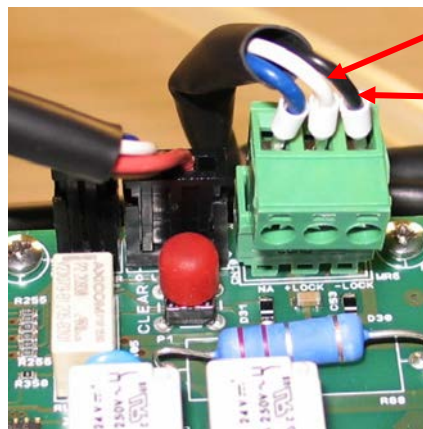
Bravo Door Motor Wiring Troll PCB Door Motor reads approx. 120 Ω

White wire to pressure switch

Black wire to door motor

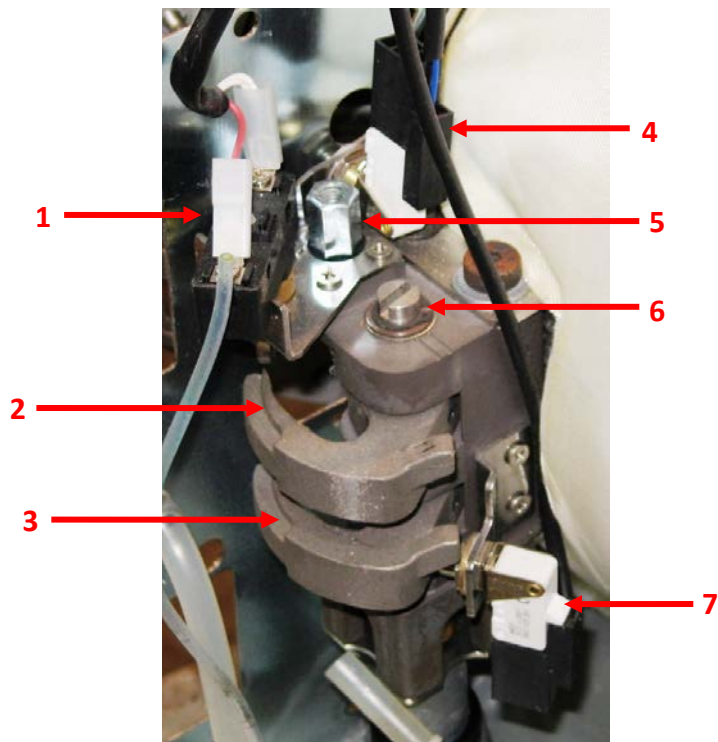
Bravo Door Motor Hook & Switch Assembly

| Item # | Description | Part # | Comments |
|---|---|---|---|
| 1 | Door Roller Switch | 43300080000 | The roller switch has normally closed contacts that will open when the switch is activated. |

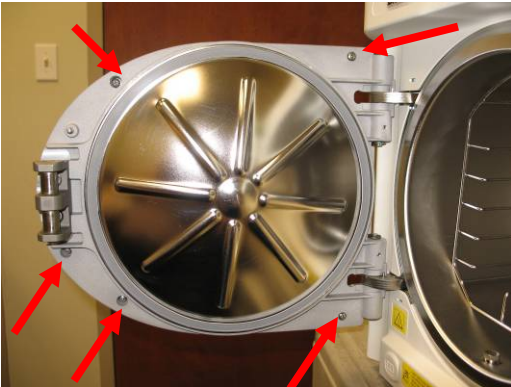
5 Door Facia Screws

To access the door switch actuator adjustment, remove the 5 screws securing the door facia to the door and remove the door facia. Loosen the door switch actuator locking nut and adjust actuator using a 3mm Allen wrench. If the door switch actuates when the door is closed but the door is pushed back open when the door motor closes adjust the actuator out so the door must close further for the door switch to close.

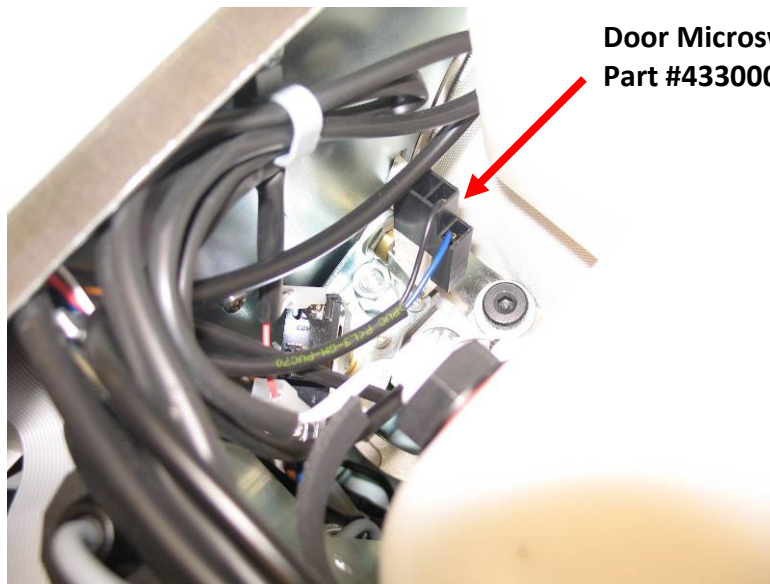
**Door Microswitch
Part #43300010000**

When a cycle is started the door must be closed and the flashing key icon should appear on the display. If no flashing key icon appears check the Door Microswitch, it is normally open and should be closed when the door is closed. Manually activate the switch and see if it closes. If door switch closes when manually activated but not when door is closed check that the switch is firmly attached to the mounting plate and has not come loose. Adjust door switch actuator.

Door Switch Actuator

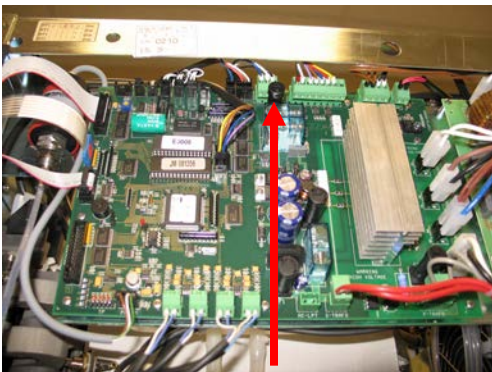
GAM PCB

Go to the Service menu (service code ++ -- ++ --), device test, manual, locking device. Select the locking device then activate the door motor and check if the door hook is closing and opening. If the door motor does not operate check fuse F4 on the Bravo Gam PCB and check the red reset button on the Troll PCB. Check the Pressure Switch you should have continuity between the two white wires.

Fuse F4

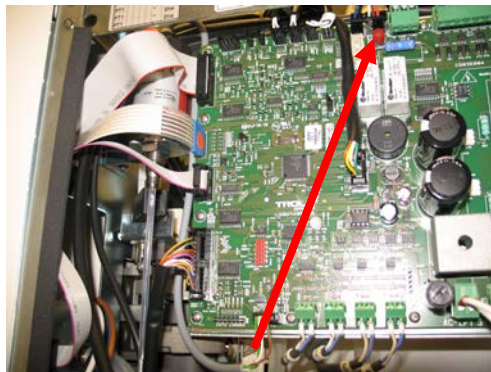
Troll PCB

Red Reset Button

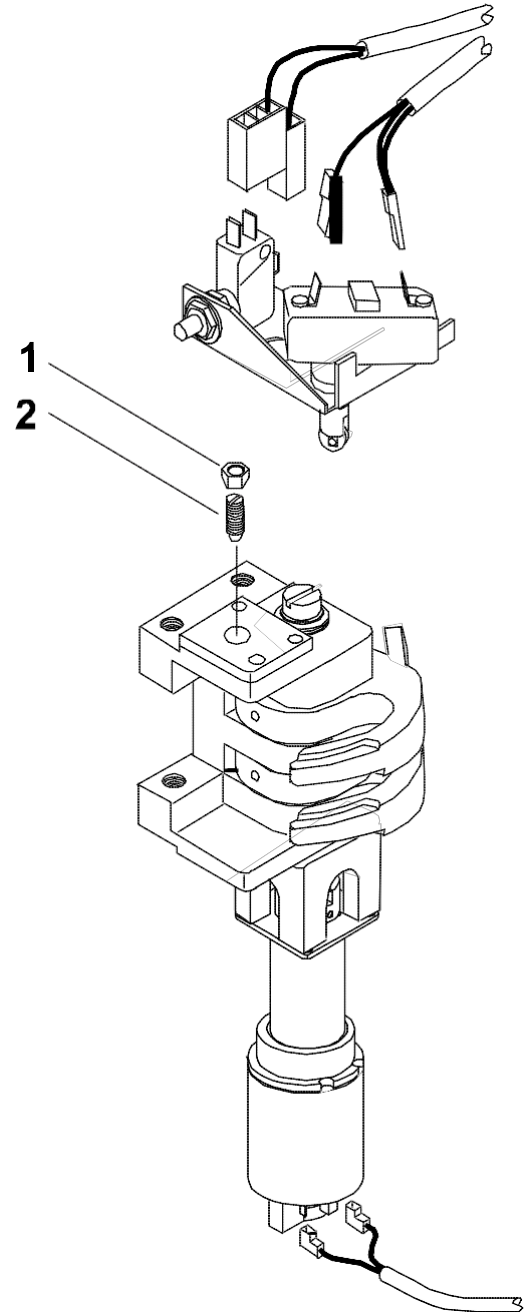
1. Remove the covers (left, upper & right).
2. Open and close the door to check its operation.
3. In case the door does not remain closed (no click at the stroke end), loosen the nut (1) and turn the positioner (2) clockwise.
4. In case of resistance on closing/opening the door, loosen the nut and turn the positioner counterclockwise.
5. Tighten the nut.
6. Perform a sterilization cycle.

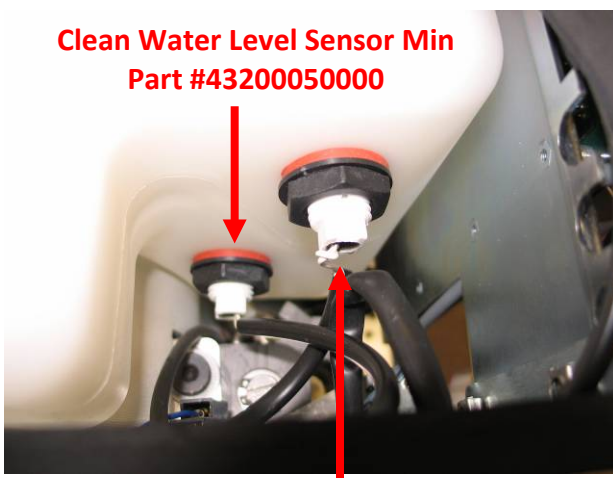
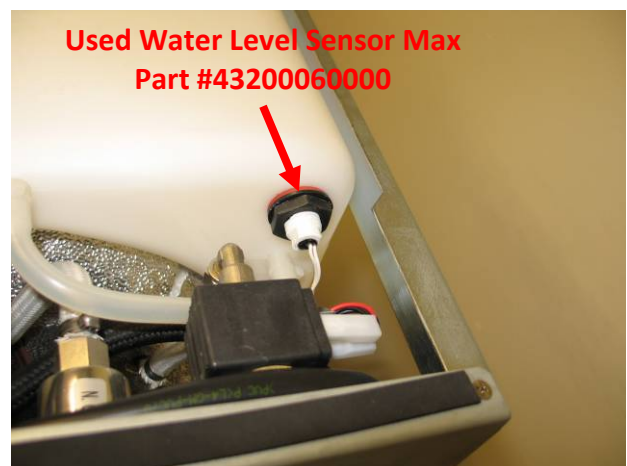
The Bravo sterilizers have three float switches. Two of them are located in the clean water reservoir and one is located in the used water reservoir. The switches in the clean water reservoir are visible from the front of the Bravo and the used water reservoir switch from the rear of the Bravo.

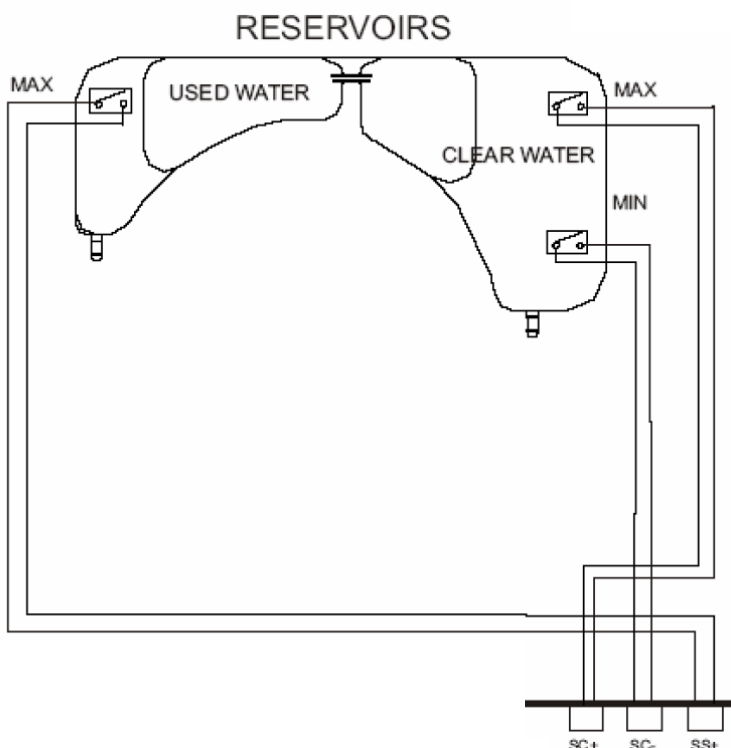
Clean Water Level Sensor Max
Part #43200050000

The used water reservoir float is wire number 1 and connects to terminal SS+ on the PCB. It is a normally closed switch.

The clean water reservoir MIN float is wire number 2 and connects to terminal SC- on the PCB. It is a normally open switch.

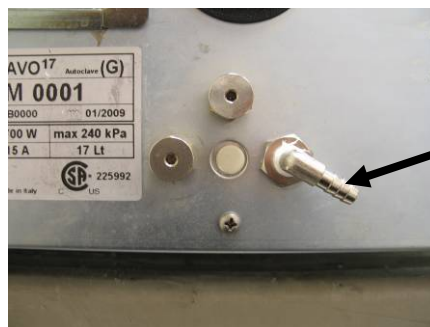
**Auxiliary Pump
Inlet Elbow**

When **error code A040** appears the auxiliary pump is not pulling water into the clean water reservoir. To prime the auxiliary pump turn the unit OFF. Go to the rear of the Bravo and remove the tube coming from the external clean water reservoir. Connect a short piece of 1/4" tubing to the auxiliary pump inlet elbow.

Fill a syringe with water and connect the syringe to the 1/4" tubing.
Turn the Bravo on and when the check-up is complete enter the Setup Mode.

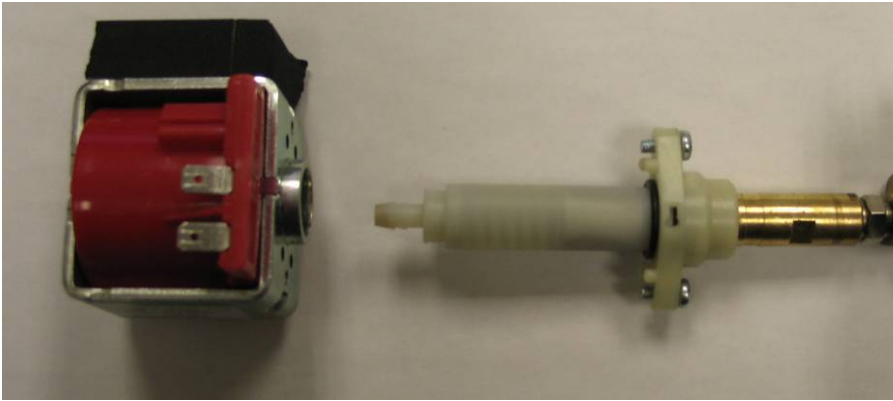
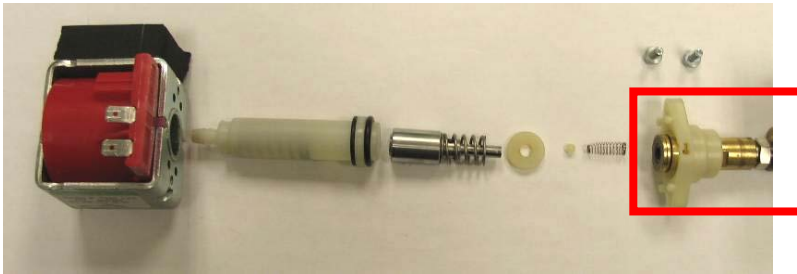
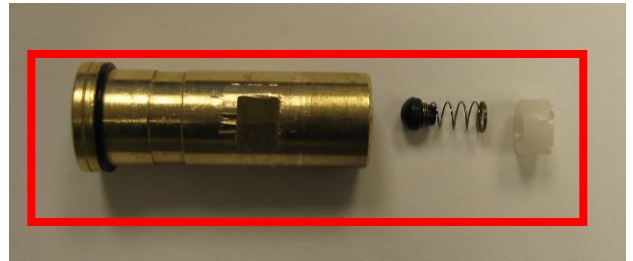
Remove two screws that hold shaft to pump coil. Hold white shaft with one hand and white mounting piece with screws with the other hand. Push pump white shaft in slightly and turn counterclockwise. Carefully disassemble pump. Reverse procedure to reassemble.

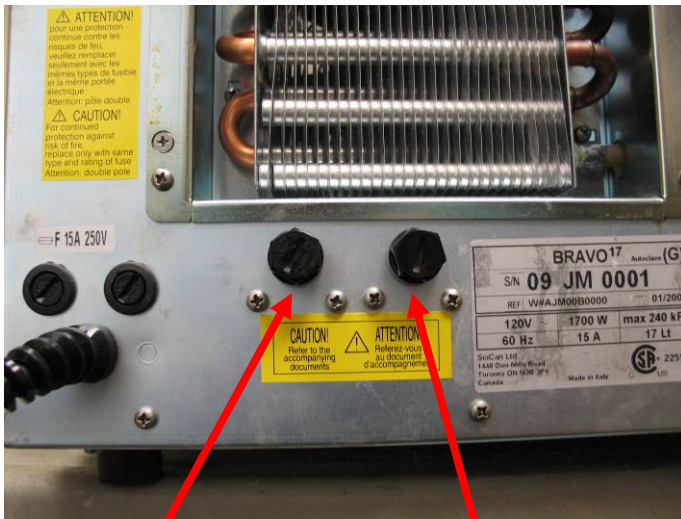
**Steam Generator
Thermostat**

Remove cap and depress button. If you hear a click the thermostat was tripped. If there is no click, the thermostat was not tripped.

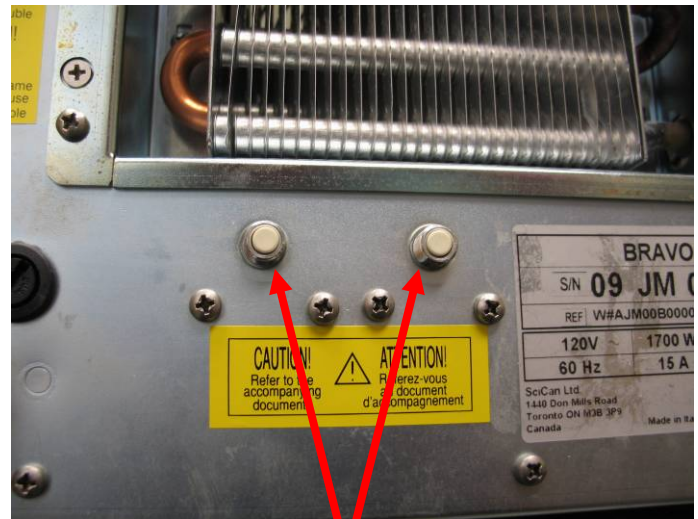
**Band Heater
Thermostat**

Press to Reset

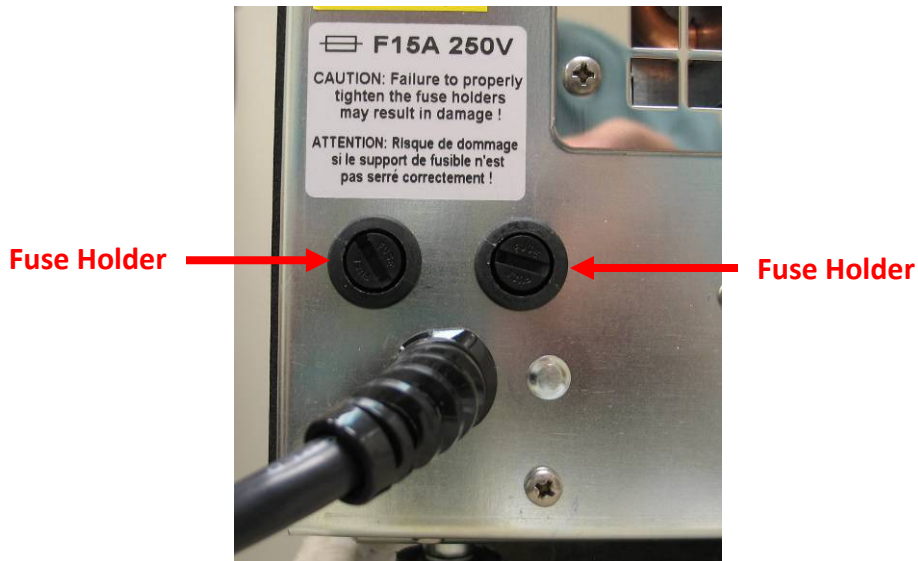
If power switch does not light up when unit is turned ON:

1. Check wall outlet for power
2. Check two 15A 250V fuses in rear of unit by the power cord.

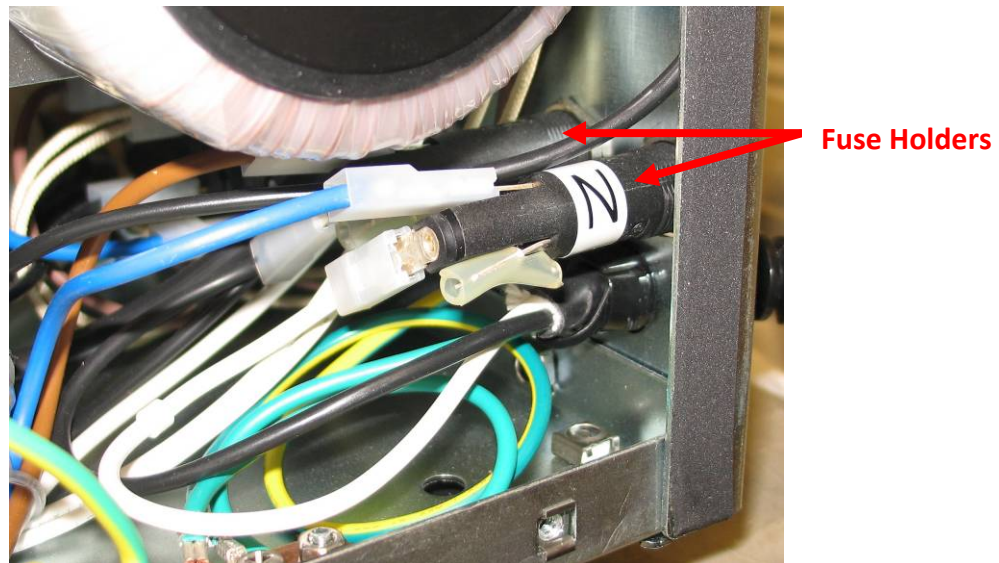
1. Check fuse holders

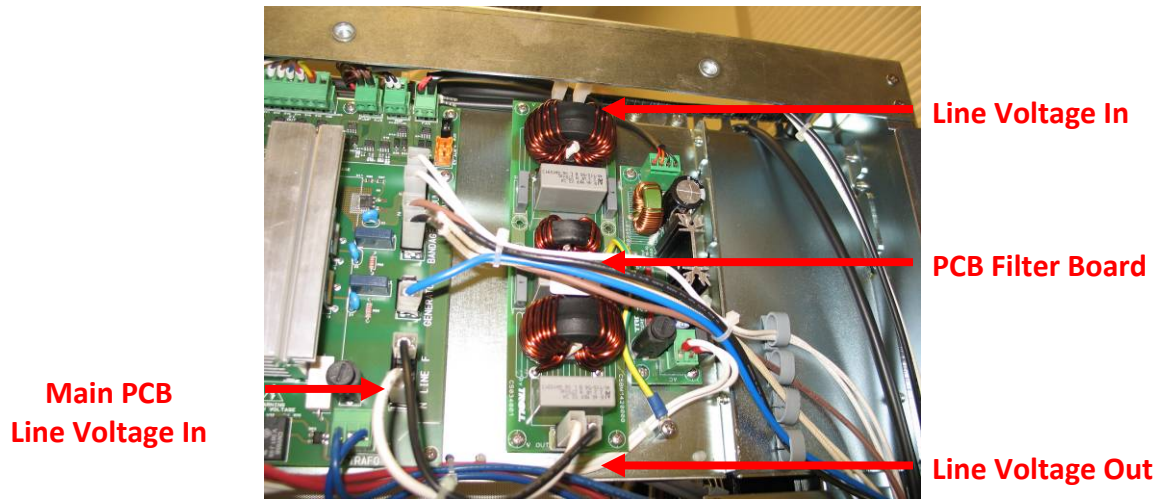
1. Check fuses on main PCB
2. Check for line voltage to PCB filter board
3. Check for line voltage from filter board to main PCB. If no voltage from filter board replace PCB filter board.

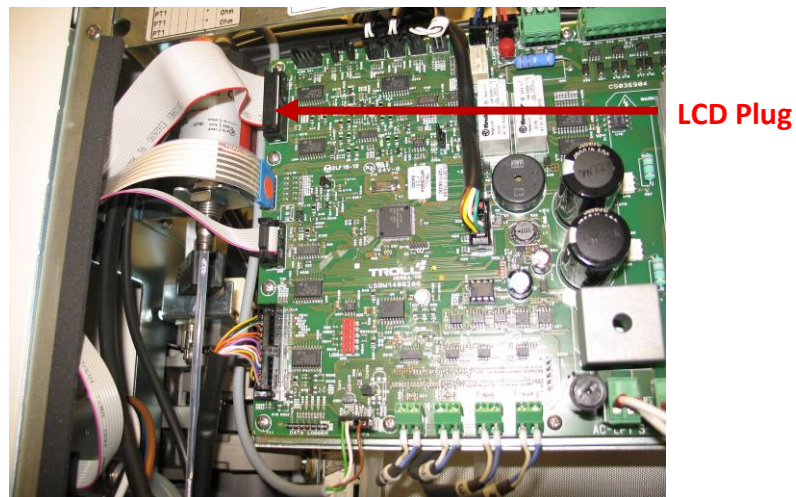
1. Check connection from LCD to left side of main PCB.
2. Replace main PCB or LCD as needed.

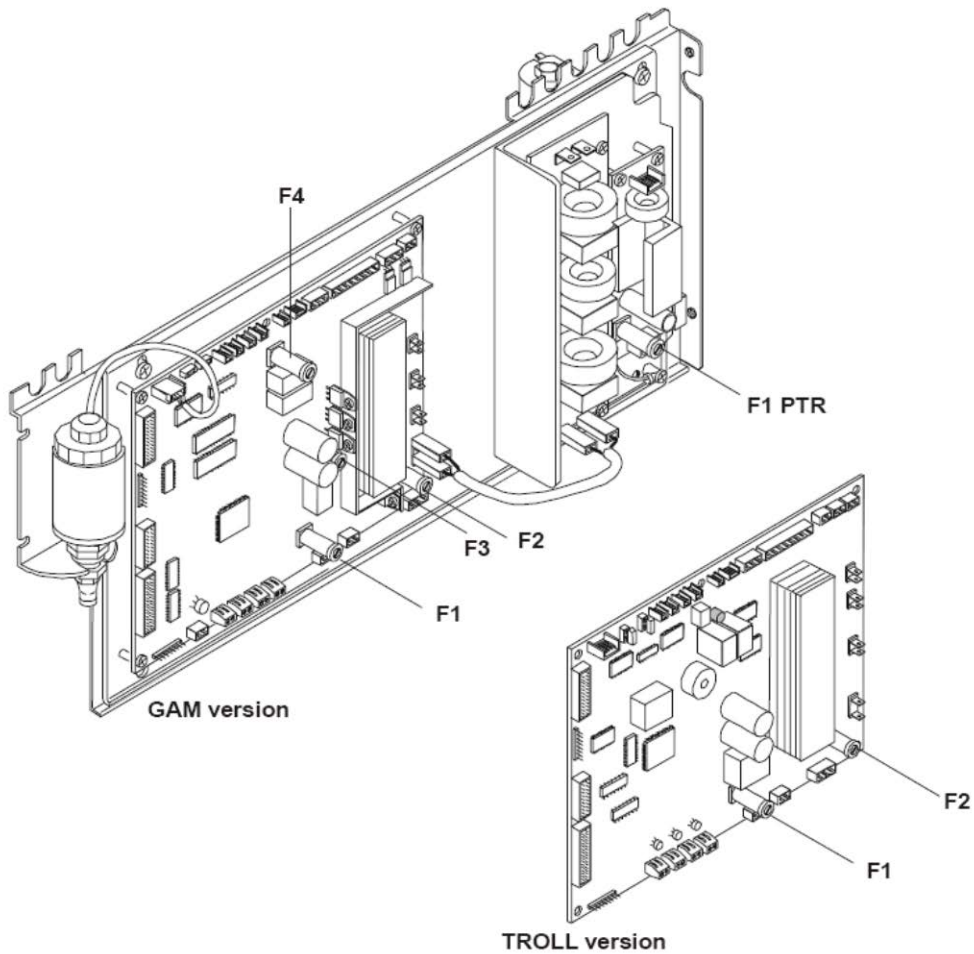
Bravo Fuses

Basic board: GAM version

F1: T 5A 250V (secondary transformer winding)

Line Fuses, F1, F2 & F3 on GAM board and F1 & F2 on Troll board will cause no display if blown.

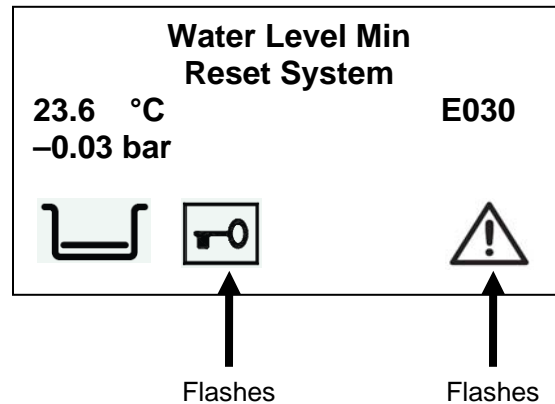
When a cycle is started in the Manual Filling Mode and the water level is below the minimum level the display will show Water Level Min Reset System and E030 will appear on the right side of the display. The empty water level icon will show in the bottom left corner of the display. The door status and alarm icons will flash. To reset system hold in the cycle select button for 3 seconds.

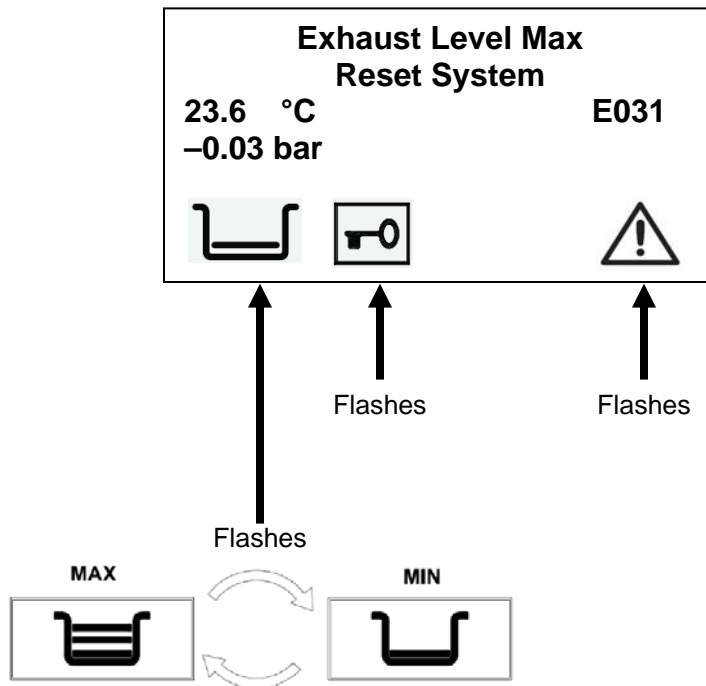
When a cycle is started and the internal drain tank is full the display will show Exhaust Level Max Reset System and E031 will appear on the right side of the display. The water level icon will flash between empty and full in the bottom left corner of the display. The door status and alarm icons will flash. Empty the internal drain tank completely and reset the system. To reset system hold in the cycle select button for 3 seconds. **Drain Options in the Advanced Menu should always be set at Internal Drain even if connection to a central drain. If External Drain is selected Exhaust Level Max will continuously appear on the display when starting a cycle.**

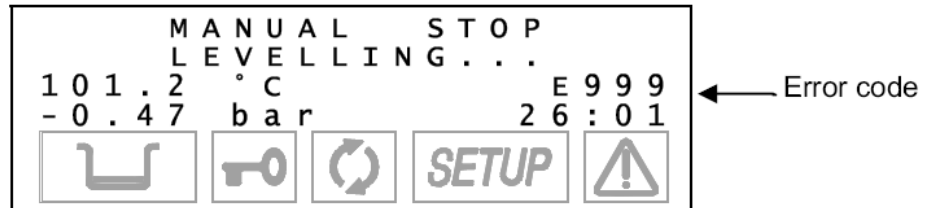
The operator can manually interrupt the cycle at any time by pressing the Start/Stop key for three seconds. This command generates an error code **E999** because the cycle did not finish correctly. Until it is safe to open the door, the unit will beep and the display will show:

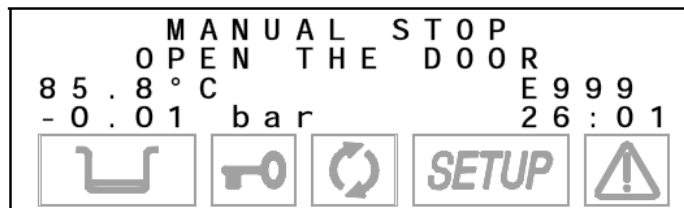
Press the ↑ key to unlock the door.
The following message is then displayed:

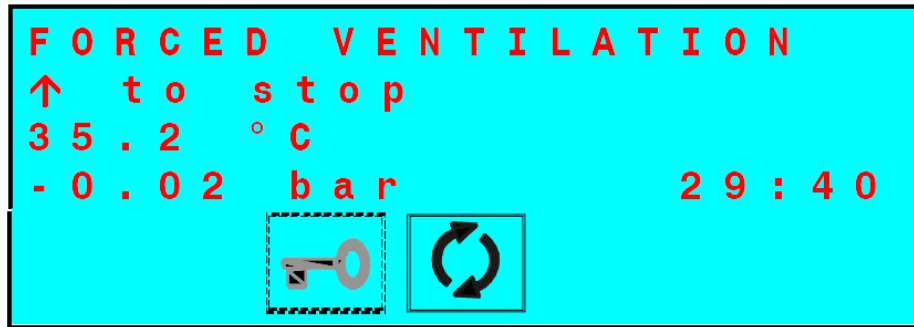
When the sterilization cycle is complete as long as the door is not opened, the vacuum pump is periodically enabled in order to remove any traces of condensate from the sterilization chamber. During these periods the display will show:

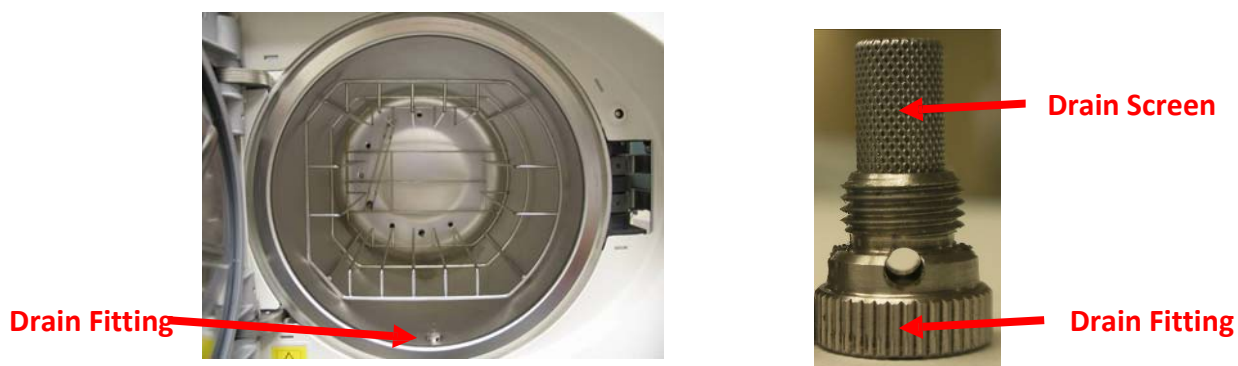
1. Check the chamber drain screen inserted into the fitting in the front of the chamber. Unscrew the fitting and remove the drain screen from the fitting. To remove the drain screen grab the end of the screen twist the fitting and pull on the drain screen. **(If you hold the drain screen in the center it will be crushed)**. Clean the inside of the drain screen using an instrument or a small flat head screwdriver. The drain screen can also be clean in an ultra-sonic cleaner. The chamber not venting (A260) is almost always a clogged drain screen.

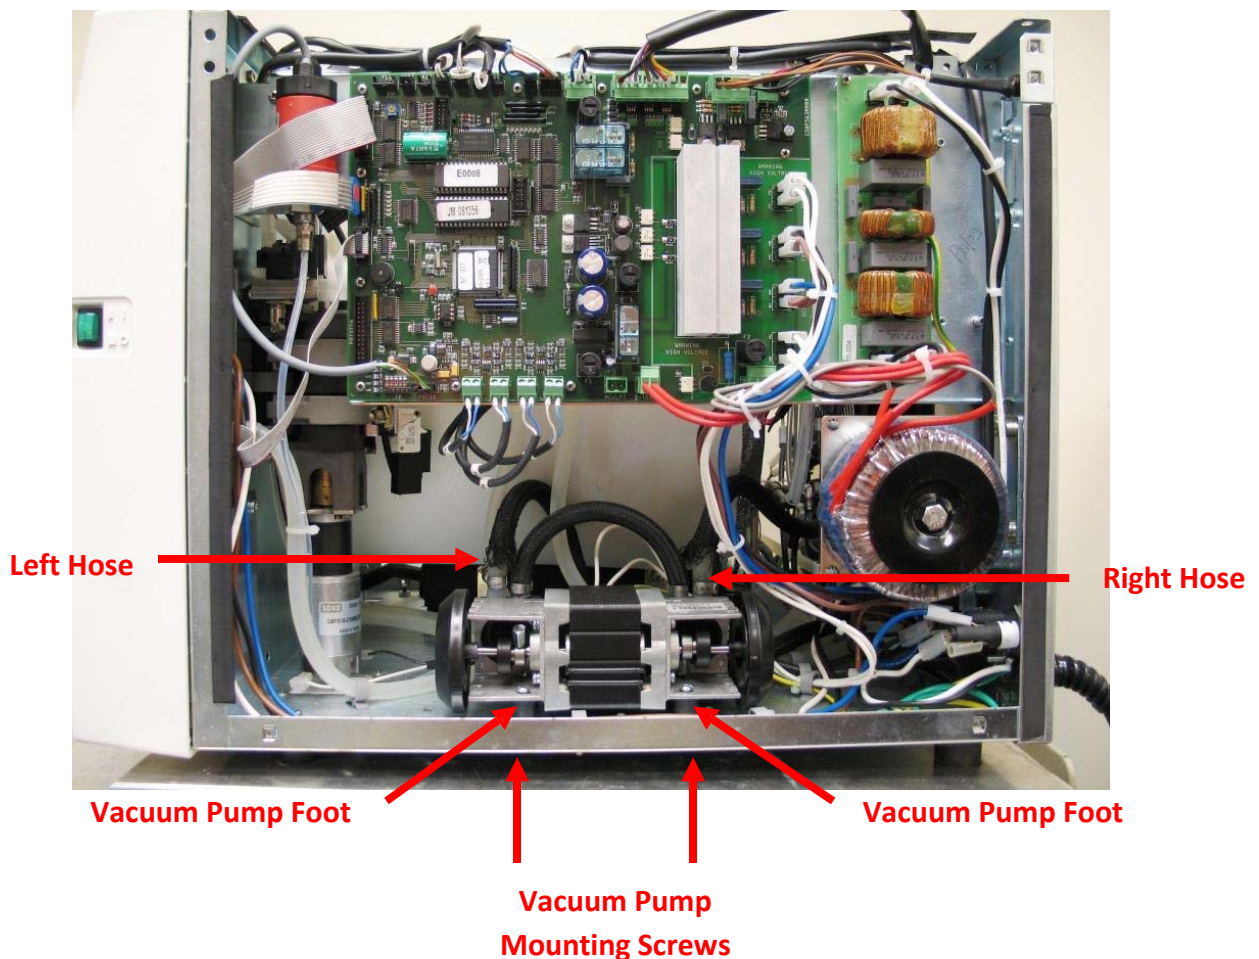
Remove the vacuum Pump from the Bravo. Slide the Bravo off the edge of a counter or drain the clean & waste water tanks and turn the Bravo on its side. Remove four screws from underneath the Bravo that screw into the vacuum pump legs. Remove the black hose on the far left side and the far right side of the vacuum pump. Roll the vacuum pump towards you and slide off the electrical connections.

White wires can go on either terminal

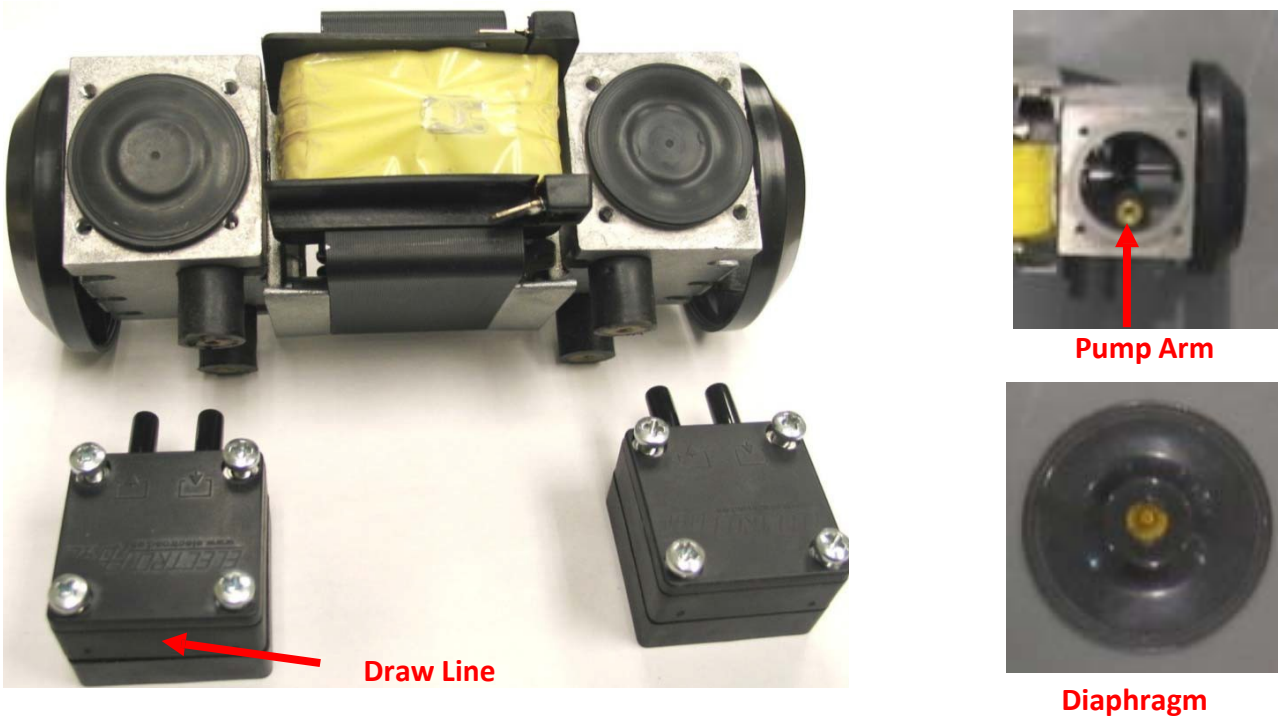
Draw a line with a marker along the black plastic heads so they can easily be aligned when reinstalling. With heads removed turn diaphragms counterclockwise to unscrew them from pump arms. When installing new diaphragms be sure to screw them completely onto the pump arms using your hand only. Disassemble black plastic heads and replaced all o-rings and shutters.

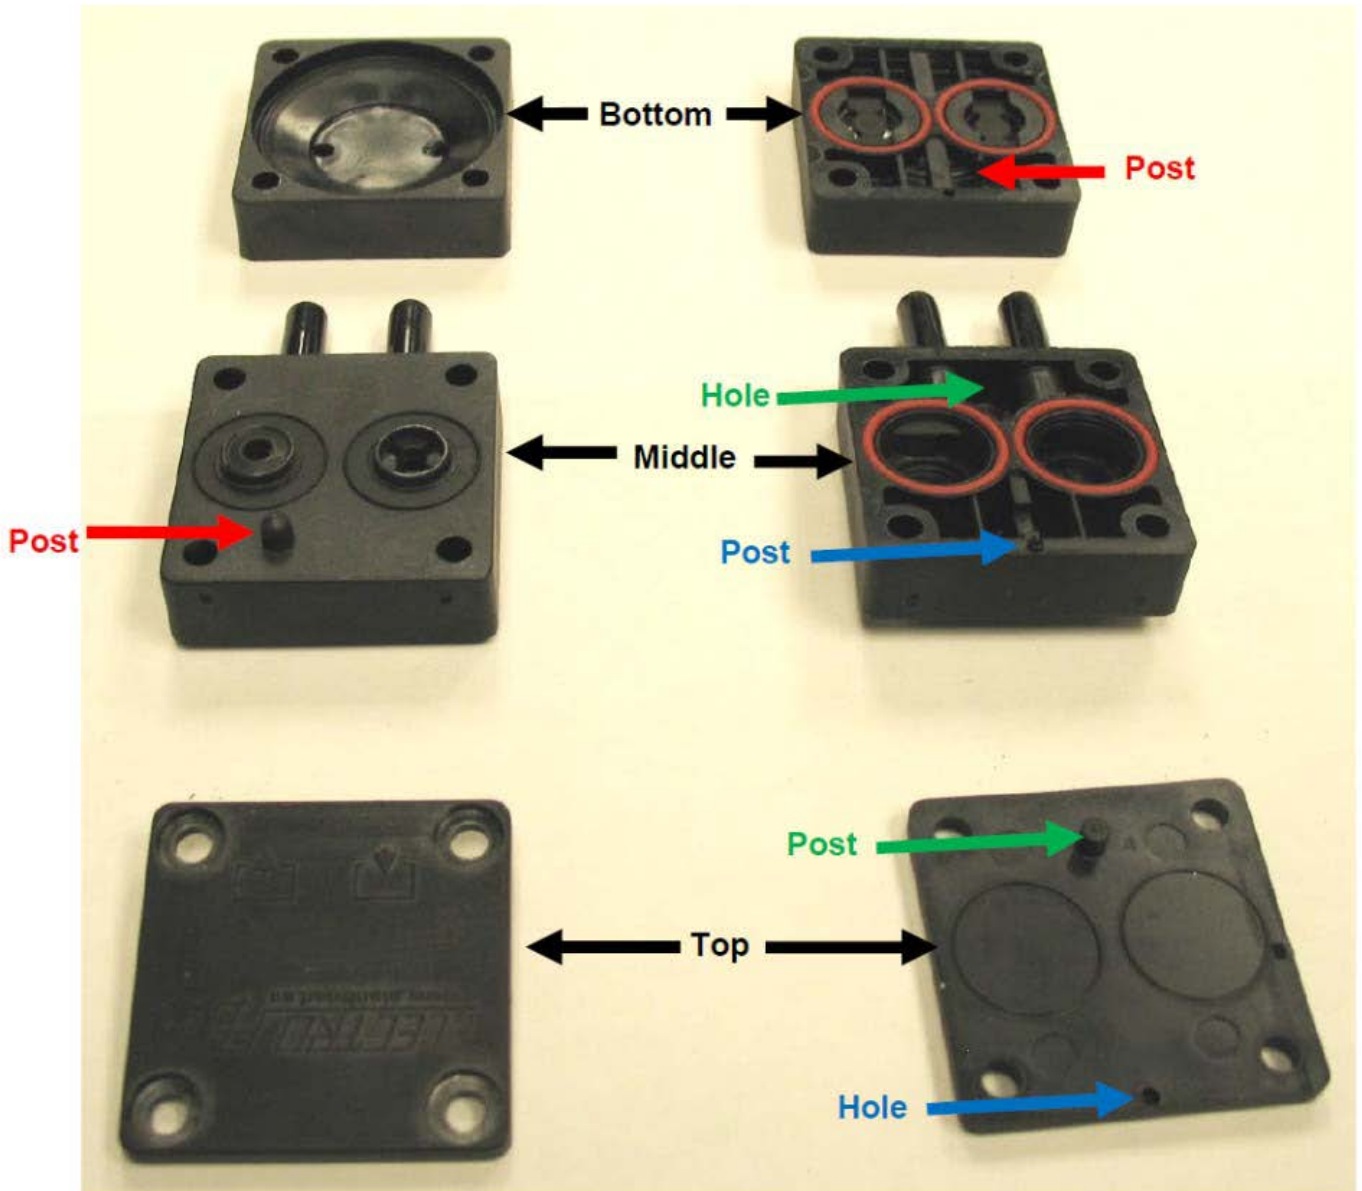
O-ring & Shutter Replacement

After replacing the o-rings and shutters place the top piece onto the middle piece and then place the middle piece onto the bottom piece. When placing the rebuilt head assembly onto the vacuum pump motor assembly be sure the new diaphragm is seated into the bottom of the head assembly.

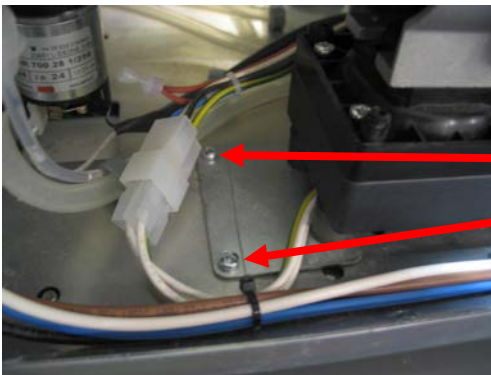
Pump with mounting plates shown here. Remove these two screws on both sides respectively.

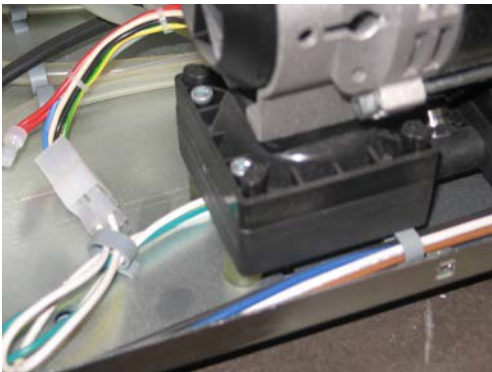
Pump without mounting plates shown here. Remove the four screws by accessing from beneath the Bravo's frame (sliding unit slightly off the edge of the work surface will allow access).

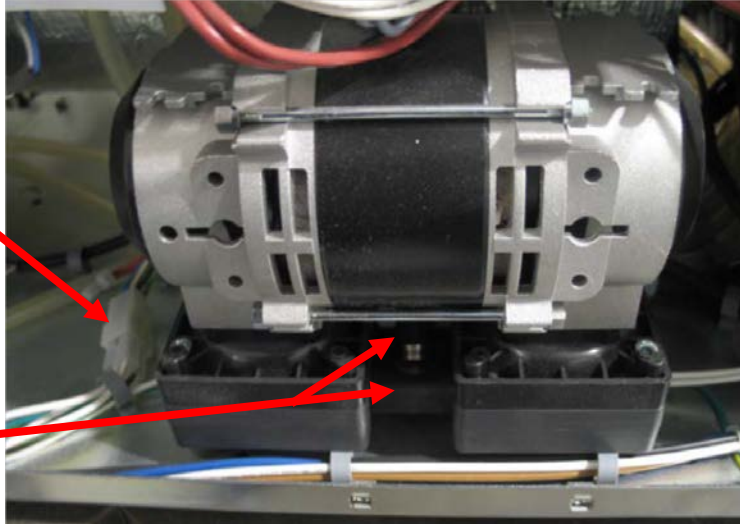
2. Disconnected wire connections on the left of the pump and slide off the two black, insulated tubes from between the two pump heads. The hose clamps do not have to be removed: the tubes will slide off with a firm pull.

Wire connections

Black, insulated tubes

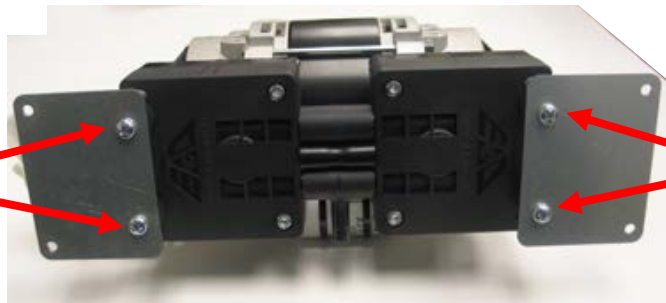
3. The vacuum pump should now be free of the Bravo frame. If your unit employed the small mounting plates (shown below), remove the four screws attaching the plates.

Screws

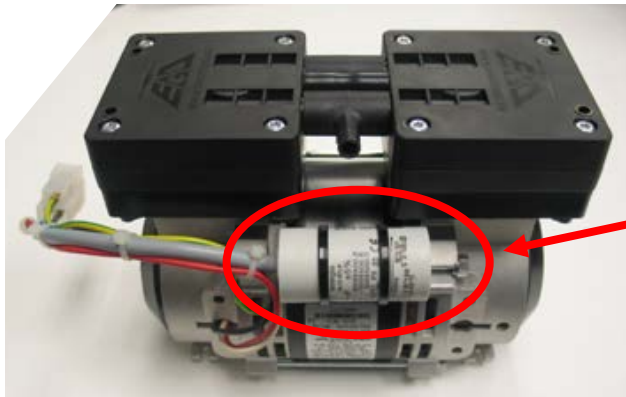
5. Now flip the vacuum pump fully upside down as shown below. Take note of the large white capacitor facing you in the photo. The capacitor will be away from view (facing the inside of the Bravo) when the pump is mounted back into place, but will be used as a visual reference for these instructions (so we know which way is front and back).

Large white capacitor for reference

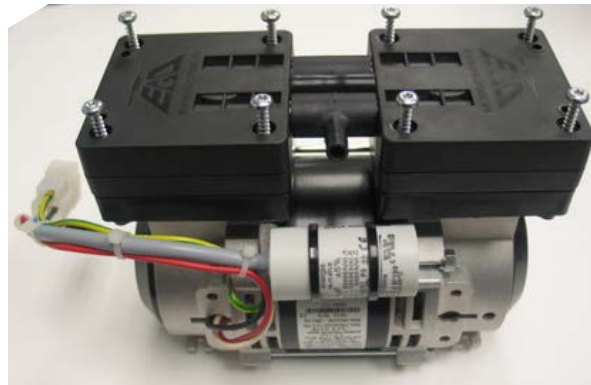
6. Now we can disassemble the head units of the vacuum pump. First, remove the four screws on each head as shown below (8 screws total).

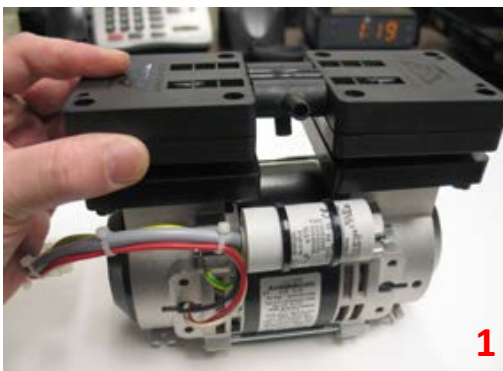
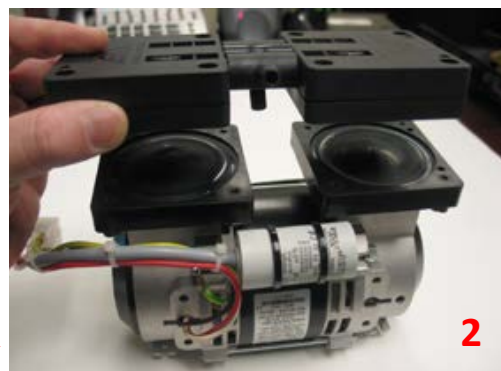
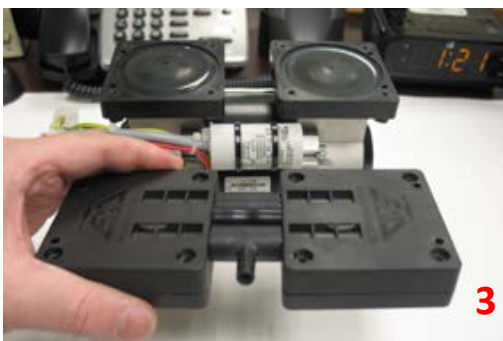
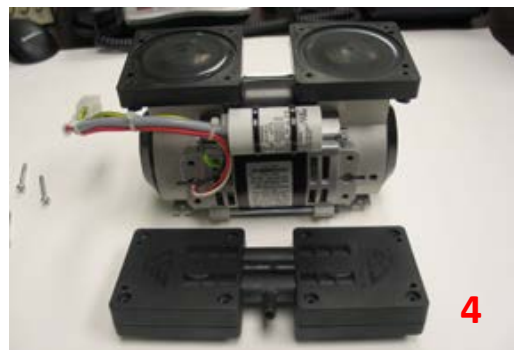
7. Now we can lift the head assembly off of the pump proper, maintaining orientation as shown below. Use both hands to prevent head sections from falling off while moving.

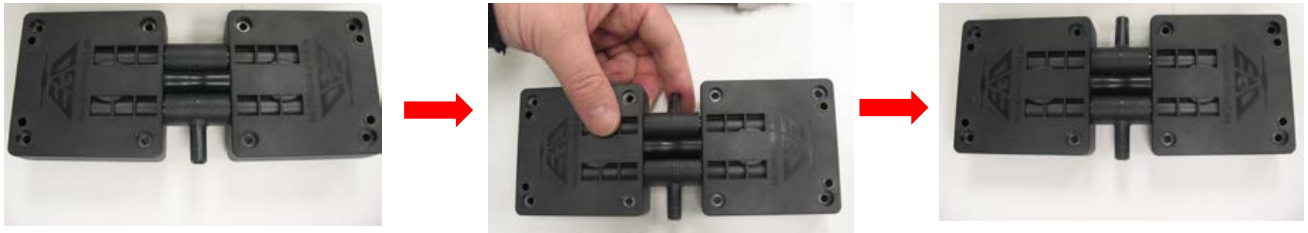
8. Looking downward at the head assembly you just removed, note the two input/output posts in between the two square heads. The output post will likely be out of view as shown below. For ease of recognition, rotate the post into view as shown below. Both direction arrows will now point in the same direction (away from you).
